**SUPPLEMENTAL UNDERWATER
ARCHEOLOGICAL INVESTIGATIONS
AT TWO REMOTE SENSING TARGETS
NEW BEDFORD HARBOR SUPERFUND SITE
Bristol County, Massachusetts**

March 2001

FOSTER WHEELER ENVIRONMENTAL CORPORATION

J. Lee Cox, Jr.
Dolan Research, Inc.

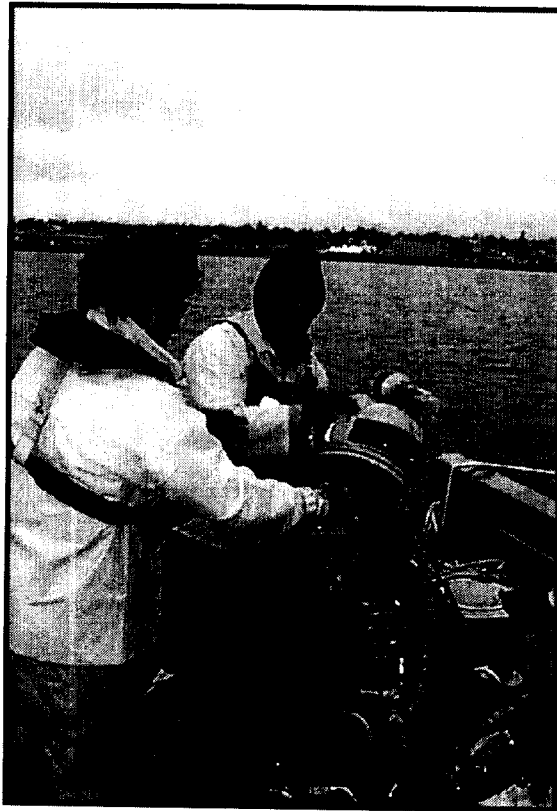
Plate 2. Tenders assisting diver prepare for target investigation
 (Photographer: Chip Ryther, 11/2000)

Diving operations were conducted jointly with divers from S.T. Hudson Engineers, an engineering firm from Camden, New Jersey. S.T. Hudson Engineers provided all surface-supply diving equipment including; two Superlite 17b surface-supplied diving helmets, two high pressure (HP) 300 cubic foot air bottles with independent high volume regulators connected to a HP air manifold with Pneumo gauge, two 150-foot diving umbilicals, a two-way hard wire surface to diver communications radio and two 30 cubic foot bail out bottle w/ scuba regulator. The divers were outfitted with Viking HD vulcanized rubber dry suits with gloves and a Superlite-17b neck sealed collar and each also had a 30 cubic foot bail-out bottle with a scuba regulator (Plates 2 and 3).

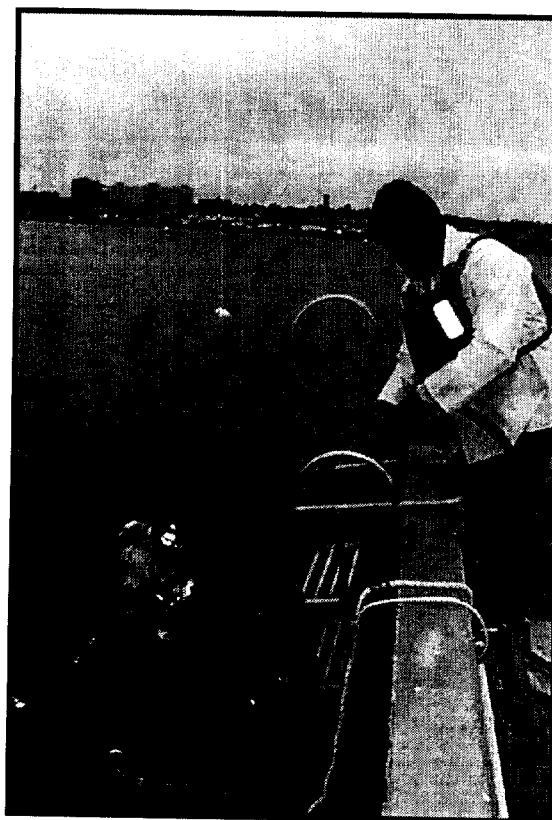
Plate 3. Diver descending dive ladder with tender handling his umbilical hose
 (Photographer: Chip Ryther, 11/2000)
